A Rapid Assessment of Sediment Delivery from Clearcut Timber Harvest Activities in the Battle Creek Watershed, Shasta and Tehama Counties, California

November, 2011

Report prepared at the request of
The California Resources Agency

The California Department of Forestry and Fire Protection (CAL FIRE)
The California Department of Fish and Game (DFG)
The Central Valley Regional Water Resource Control Board (CV RWQCB)
and
The California Geological Survey (CGS)

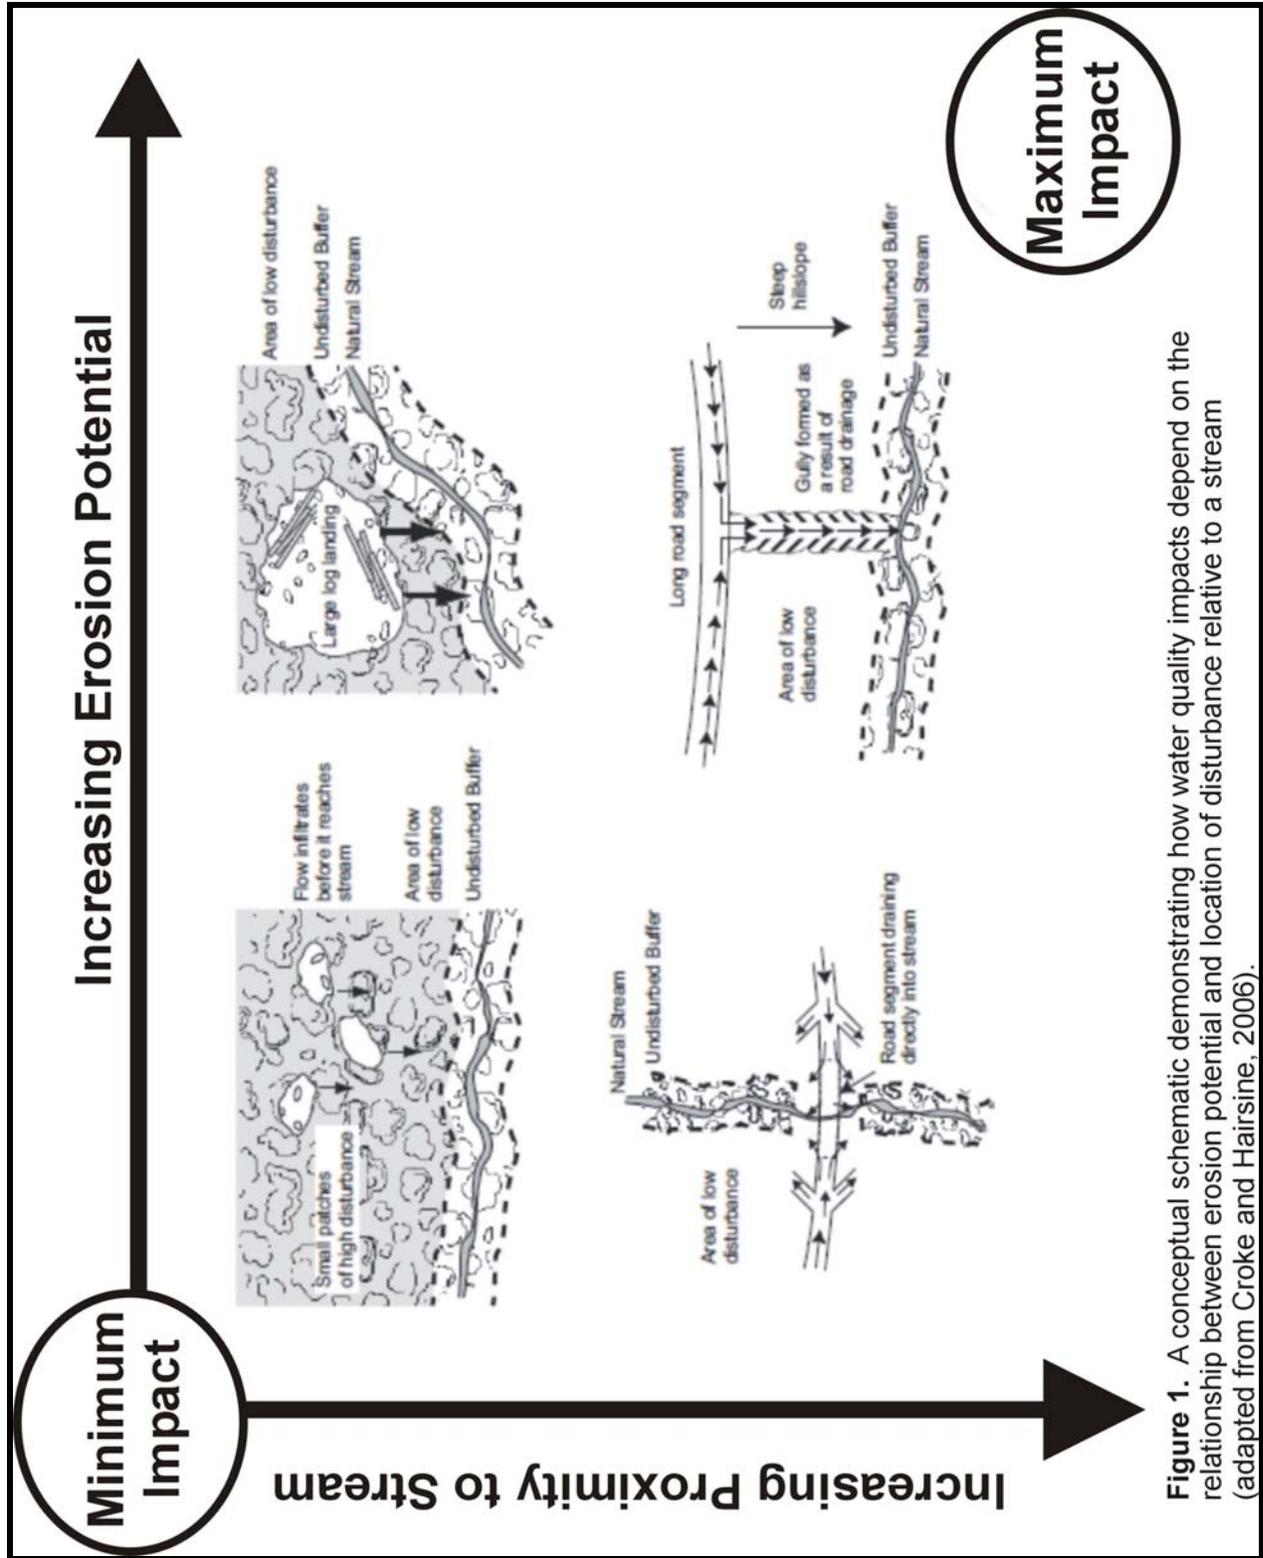
The potential for sediment delivery from timber-harvest activities strongly depends on the interaction between the location of the activity relative to a waterbody and the erosion potential of the activity (Croke and Hairsine, 2006) (Figure 1). The location of the activity is important because eroded sediment from a disturbed site can rapidly settle as it discharges onto undisturbed forest floor and the further an activity is from a watercourse the more likely it will be that eroded material will deposit before it reaches the water and causes a water-quality impact. In fact, the ability of the undisturbed forest floor to filter sediment is a fundamental concept used in forestry-related “Best Management Practices² (BMPs), and the California Forest Practice Rules rely heavily on riparian buffer strips to prevent sediment delivery from timber-harvest activities. Hence, the likelihood of sediment delivery generally decreases as distance from the watercourse increases.

Figure 1. A conceptual schematic demonstrating how water quality impacts depend on the relationship between erosion potential and location of disturbance relative to a stream (adapted from Croke and Hairsine, 2006).

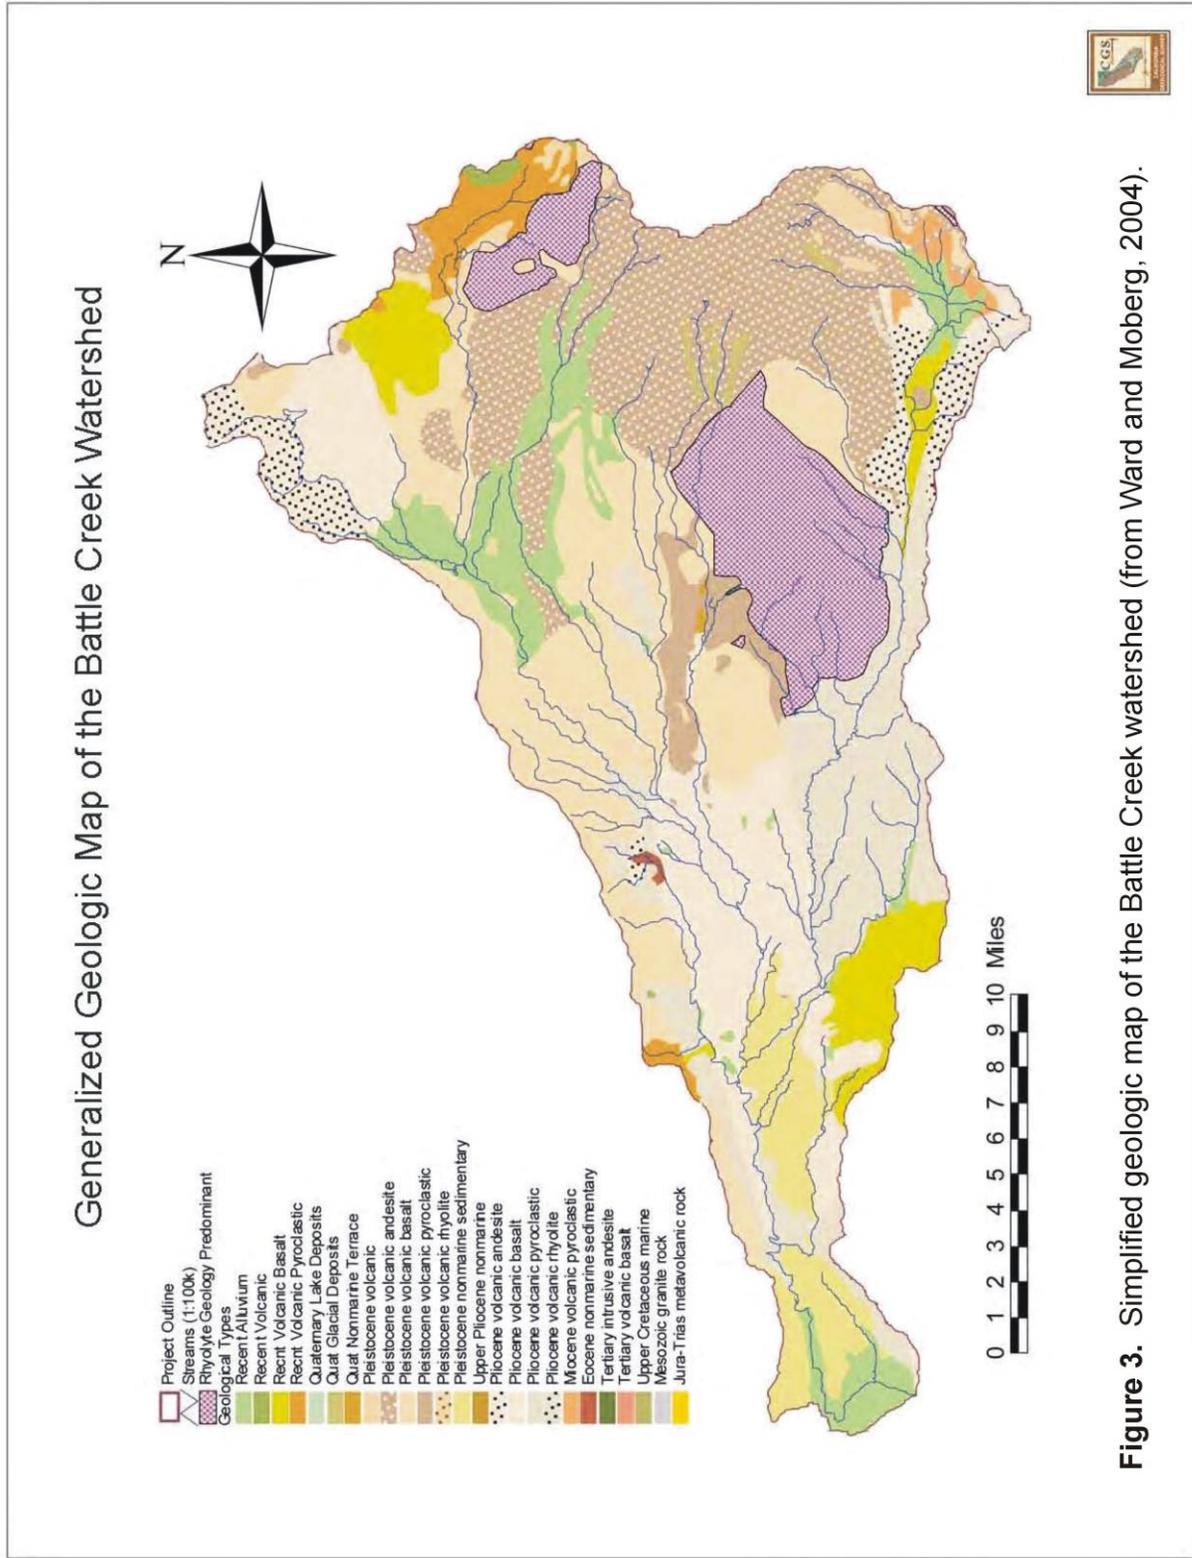
Figure 3. Simplified geologic map of the Battle Creek watershed (from Ward and Moberg, 2004).

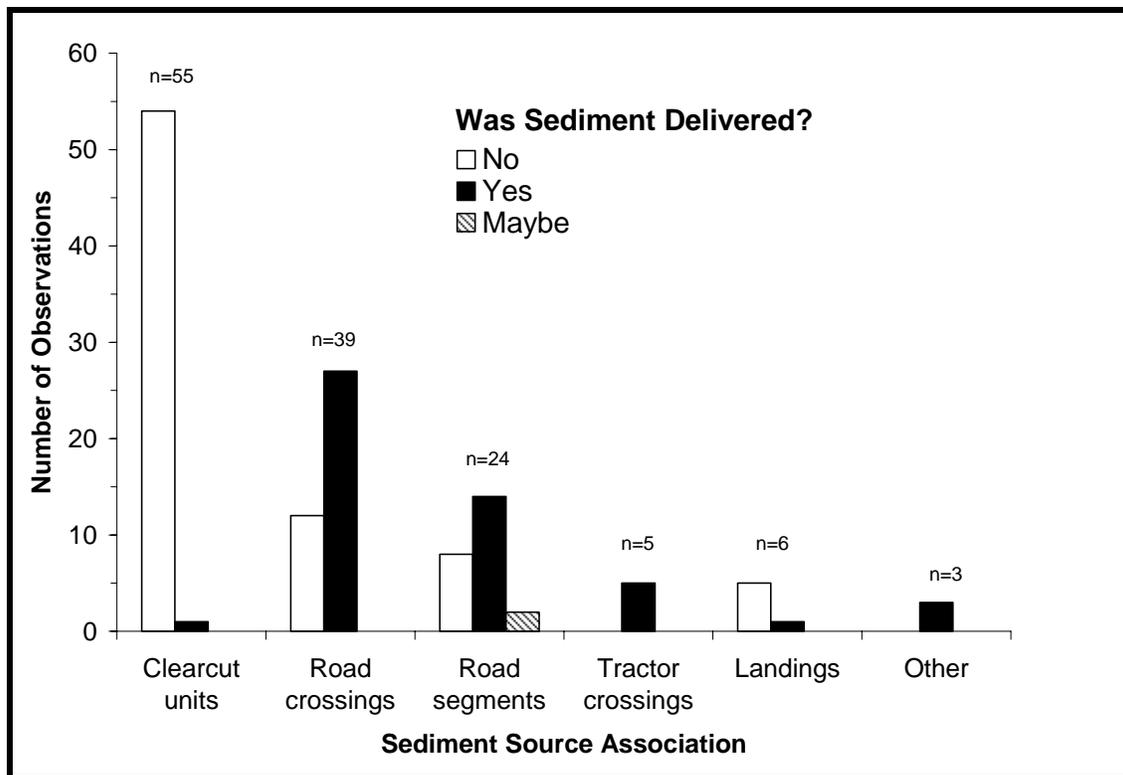
- Only one (1) of the 55 harvest units (i.e., < 2%) was determined to have delivered sediment (Figures 10 and 11);
- Sixty-nine percent (69%) of road crossings delivered sediment (Figure 11);
- Sixty-seven percent (67%) of watercourse-adjacent road segments delivered sediment (Figure 11);
- All 5 tractor crossings (100%) displayed evidence of sediment delivery (Figures 10 and 11);
- Only one (1) of the six landings (17%) delivered sediment (Figure 10).

Figure 10. Number of observations of sediment delivery by sediment source association.

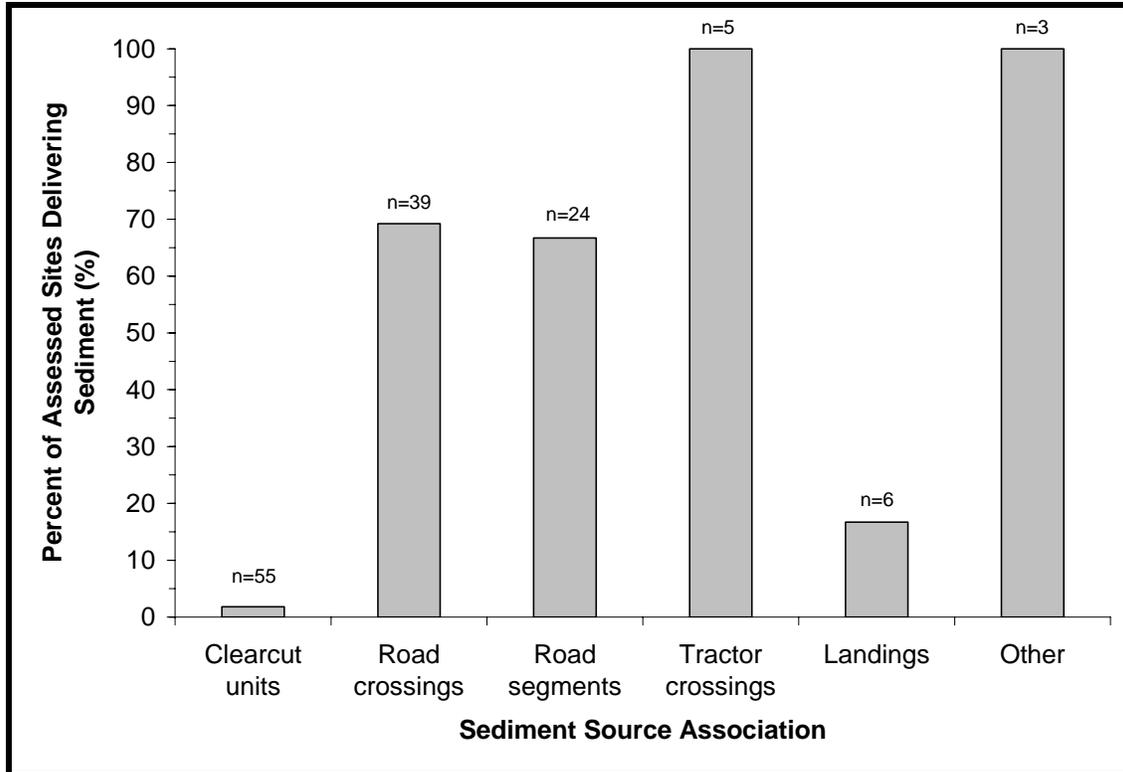
Figure 11. Percentage of sites delivering sediment by sediment source association.

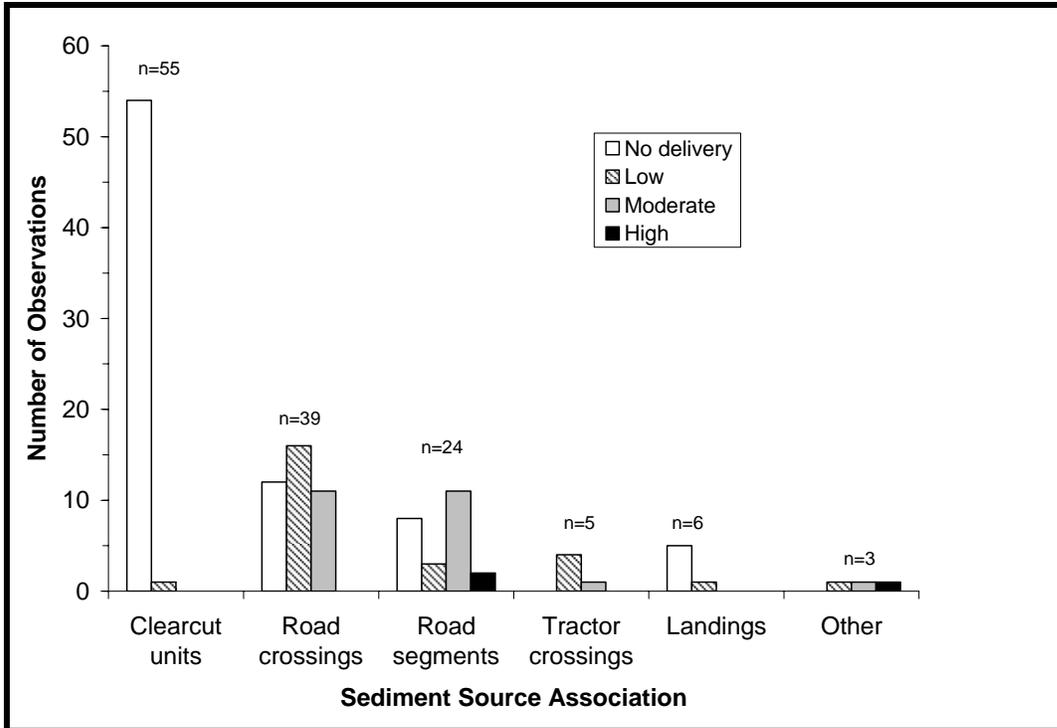
The magnitude of observed sediment delivery was found to vary by sediment source (Figure 12):

Figure 12. Magnitude of sediment delivery by sediment source association.

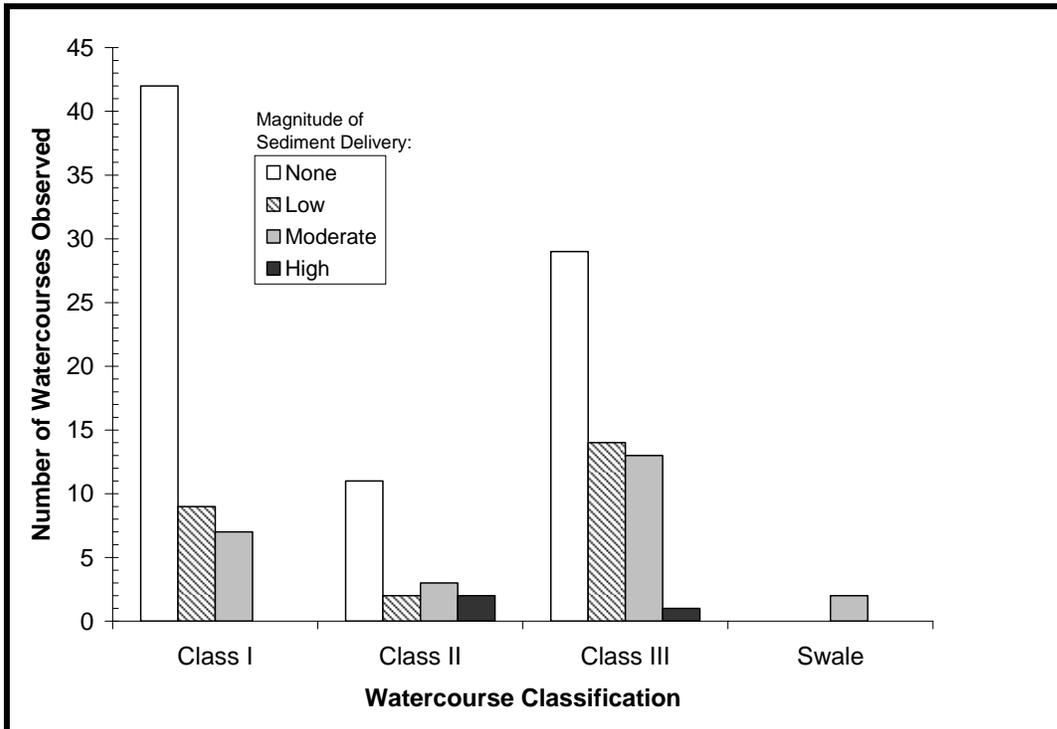
The distribution of observed sediment delivery to types of watercourses was found to vary as follows (Figures 13 and 14):

Figure 13. Magnitude of sediment delivery by watercourse classification.

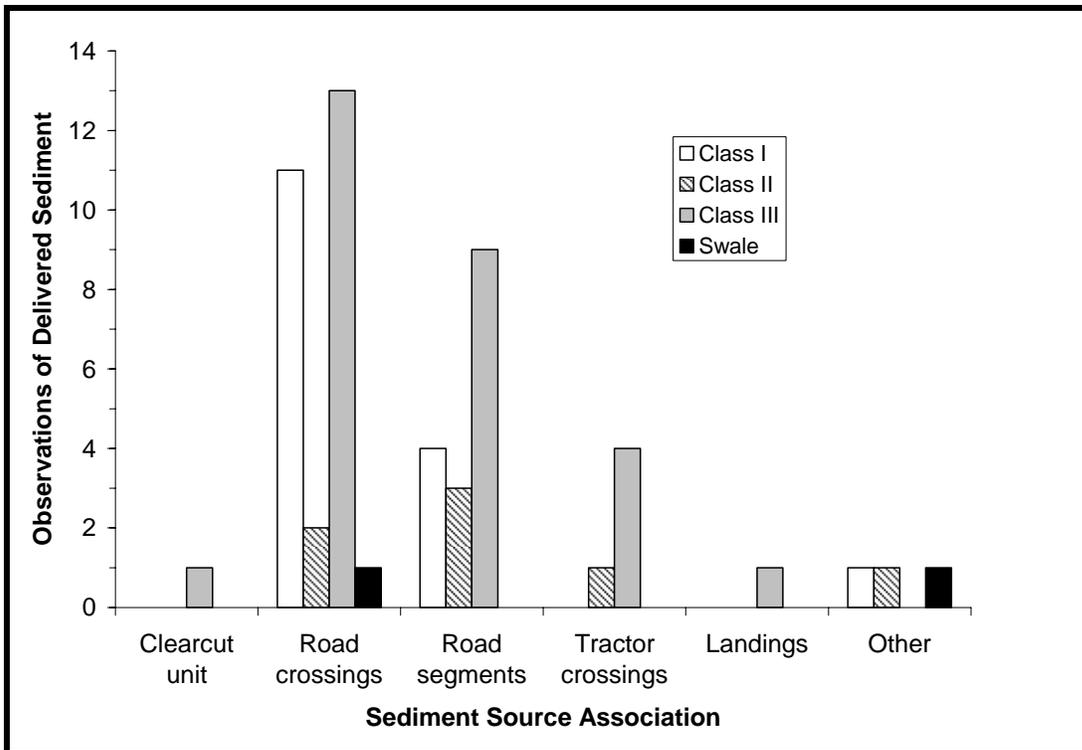
Figure 14. Sediment delivery to Class I, II, and III watercourses by sediment source association.

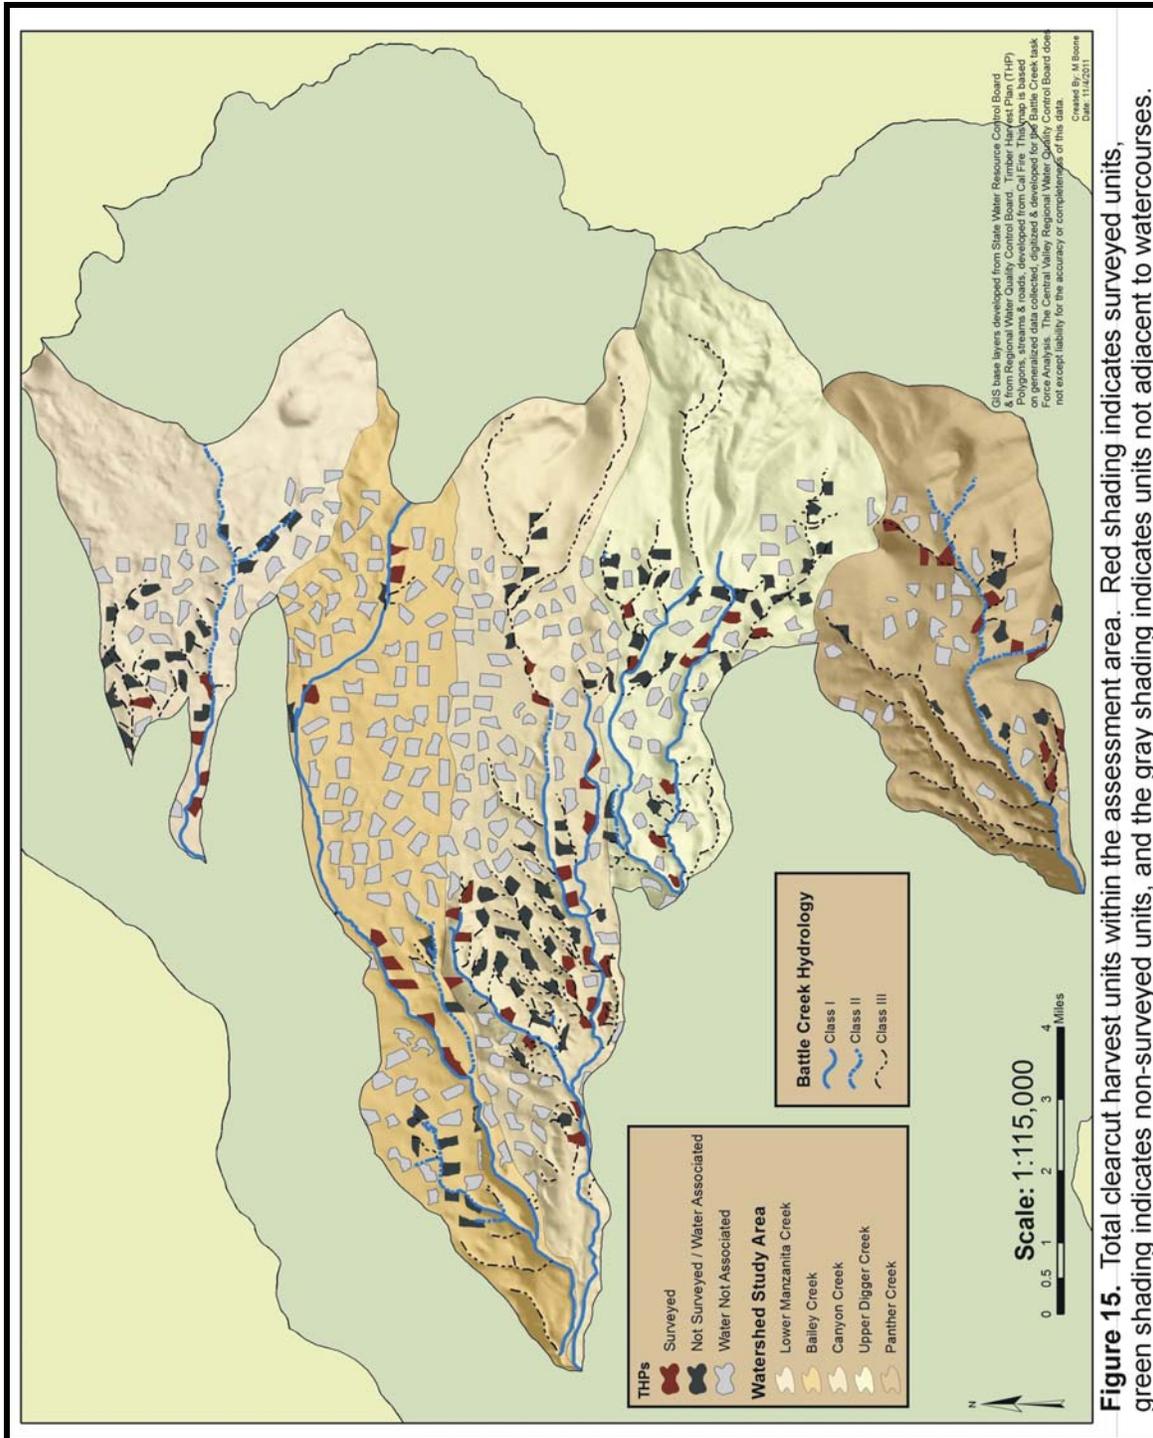
Figure 15. Total clearcut harvest units within the assessment area. Red shading indicates surveyed units, green shading indicates non-surveyed units, and the gray shading indicates units not adjacent to watercourses.

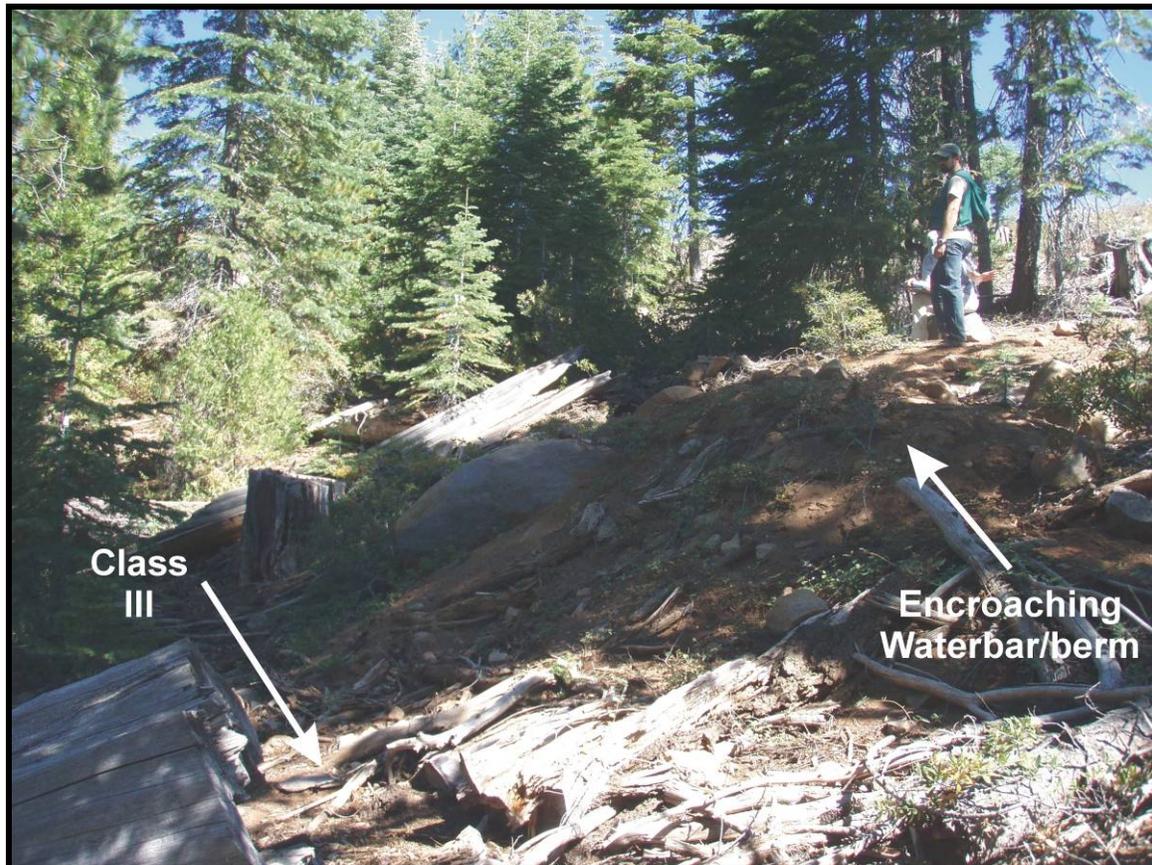
The single case of sediment delivery associated with a clearcut unit was resulted from encroachment of a tractor into the equipment limitation zone (ELZ) of a Class III watercourse, and was not a result of erosion generated within the unit. The tractor entered the ELZ and constructed a waterbar/berm within 15 feet of a Class III watercourse (Figure 16). Substantially less than a cubic yard of soil (i.e., less than 1 cubic foot of sediment) from the waterbar/berm deposited within the high water mark of the Class III. Although the encroachment of the tractor into the ELZ constitutes a violation of the Forest Practice Rules, the violation was not identified during previous inspections.

Figure 16. A clearcut harvest-unit site where sediment was observed to deliver to waters of the state. The tractor encroached within the equipment limitation zone (ELZ) and constructed a waterbar/berm. A small volume of soil from the waterbar/berm deposited within the high water mark of the Class III watercourse.

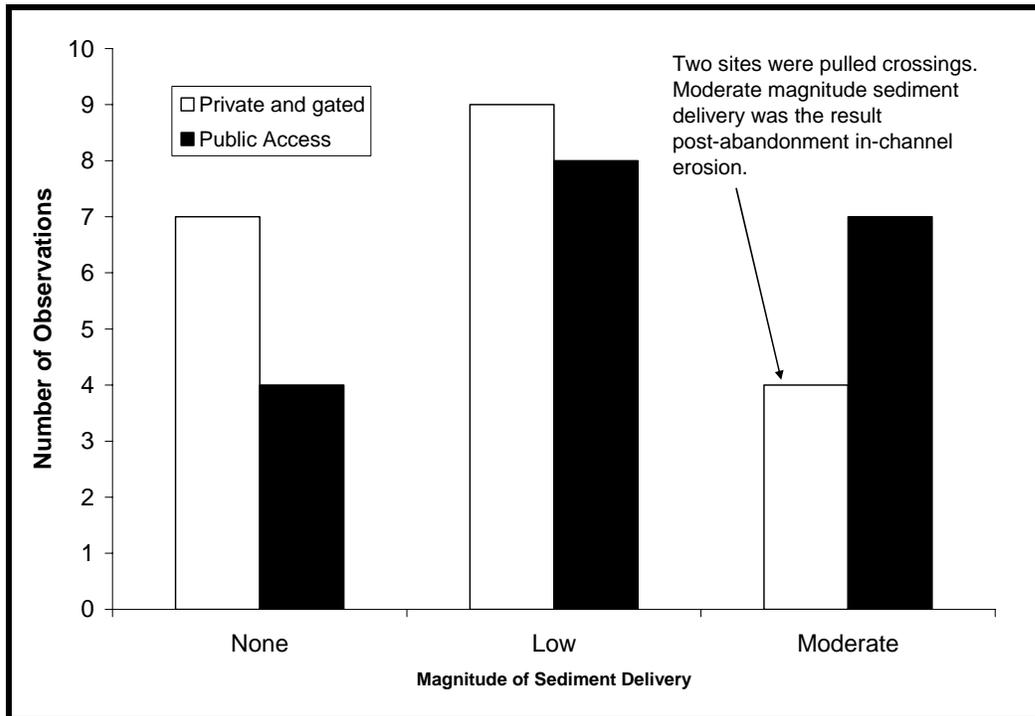
Figure 17. Magnitude of sediment delivery for road crossings by road ownership and use designation. Private and gated refers to crossings on SPI-managed roads that are behind locked gates. Public access refers to crossings on roads managed by the county or ungated SPI-managed roads that are accessible to the public.

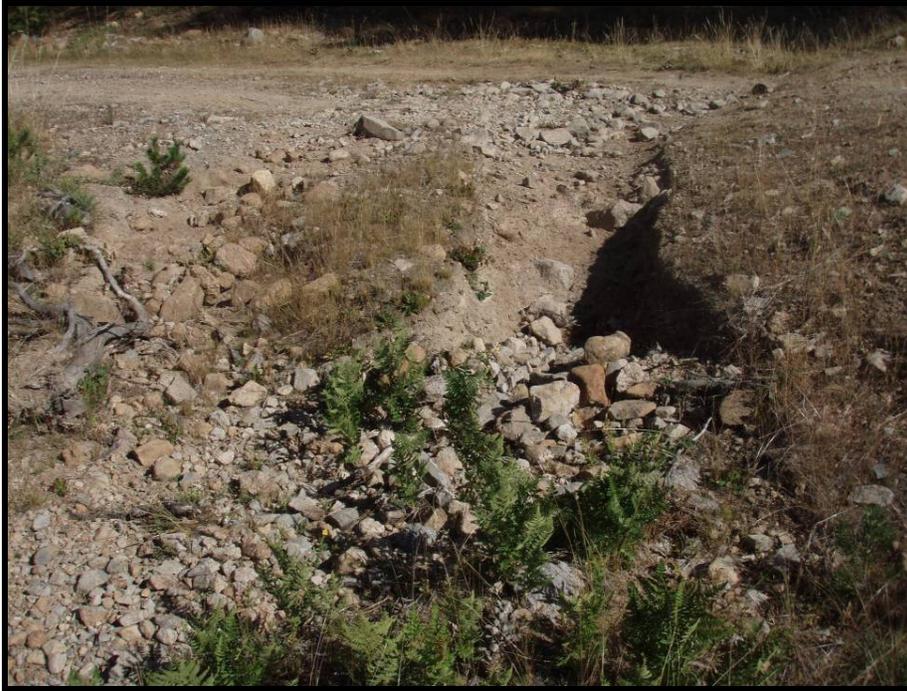
Figure 18. Gully erosion below a road segment. Runoff from a long length of undrained road combined with an intercepted Class III watercourse to initiate a gully below the road. The gully eventually delivered to a Class III watercourse.

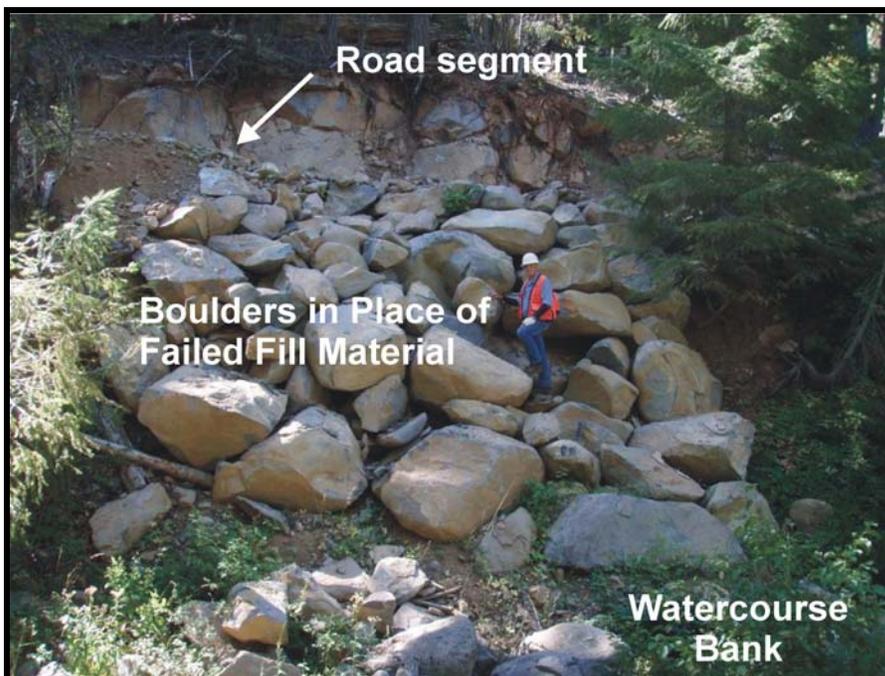
The magnitude of sediment delivery for watercourse-adjacent road segments was low for 3 road segments, moderate for 11 road segments, and high for 2 road segments. The two sites with a high magnitude of sediment delivery were associated with a road fillslope failure (Figure 19) and with a road segment that was directly adjacent to a Class III watercourse for approximately one-quarter of

Figure 19. A watercourse-adjacent road segment that delivered a high magnitude of sediment to a Class II watercourse. The road fillslope appeared to have been undermined by bank erosion and the failed fill material delivered to the adjacent watercourse via landsliding. Large boulders have been placed in the slide scar to support the road and prevent further erosion and sliding.

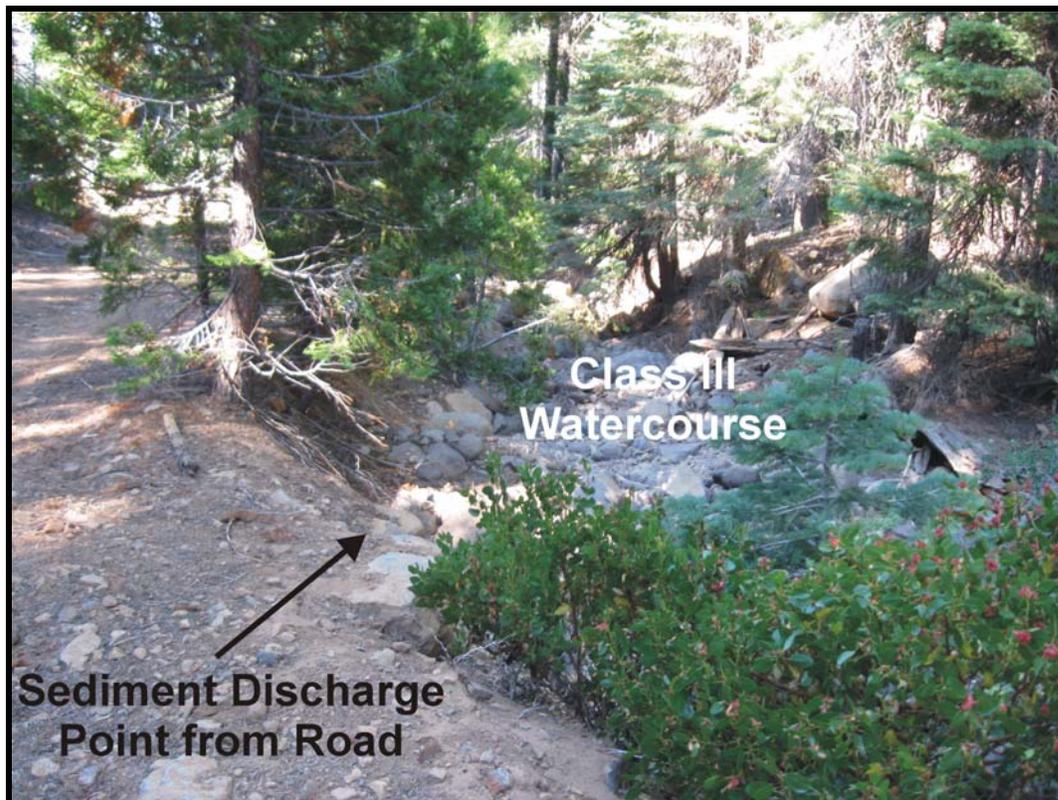
a mile (Figure 20). The road fillslope failure was not associated with recent harvest activity. However, the road segment adjacent to the Class III was subject to a Forest Practice Rules violation and civil penalty in 2006.

Figure 20. A road segment directly adjacent to a Class III watercourse. Sediment delivery is difficult to mitigate here because of the lack of buffer strip between the road and watercourse. This road segment was subject to a violation and civil penalty in 2006.

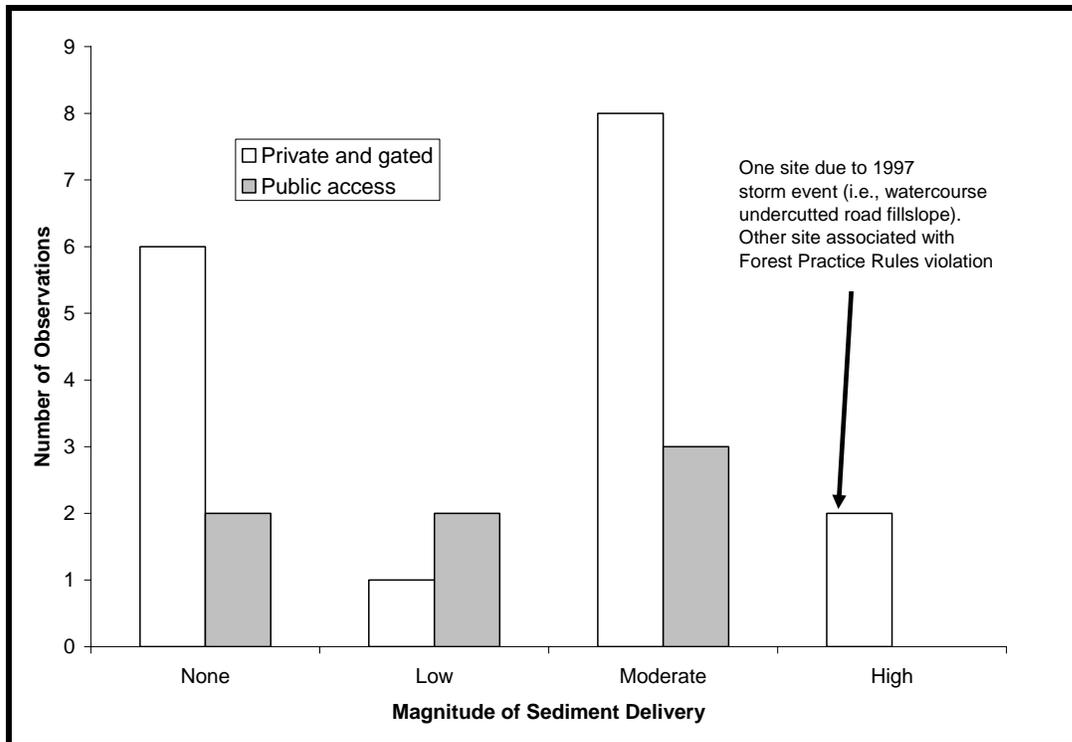
Figure 21. Magnitude of sediment delivery for watercourse-adjacent road segments by road ownership and use designation.

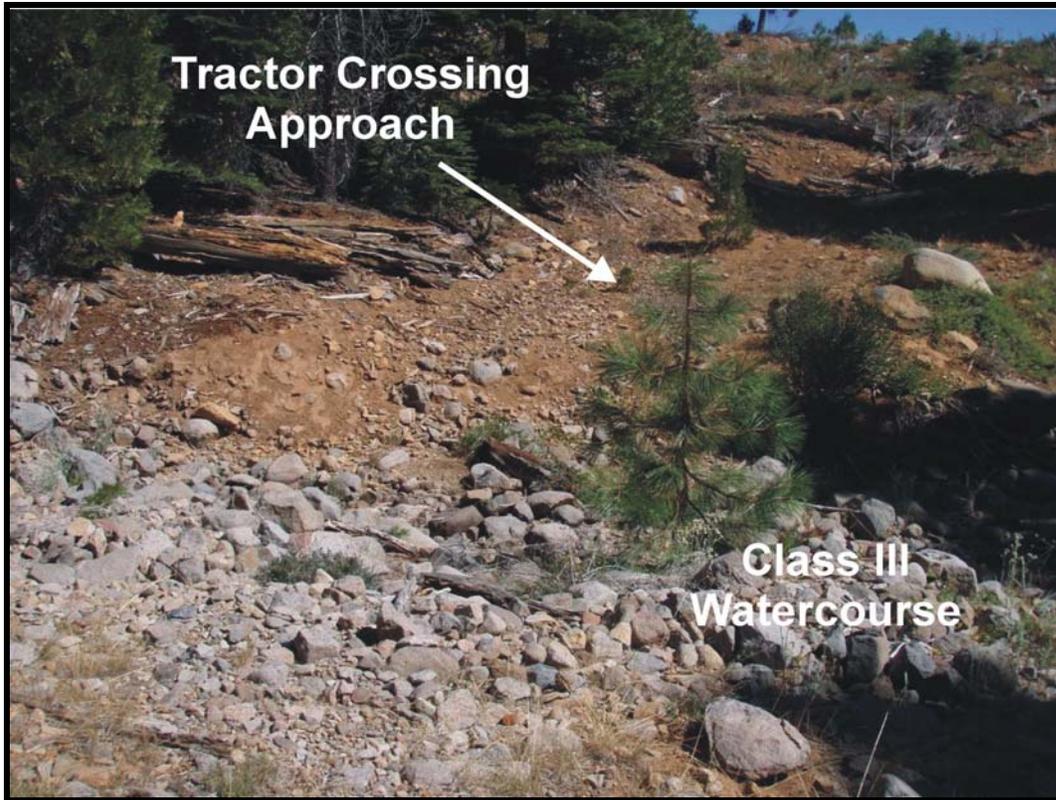
All 5 of the tractor crossings assessed by the Task Force showed evidence of sediment delivery. Four (4) of the crossings (80%) were on Class III watercourses and 1 (20%) was on a Class II watercourse. All 5 of the tractor crossings showed evidence of in-channel erosion of the residual fill material left behind in the watercourse after the crossing was abandoned. Four (4) of the 5 crossings (80%) displayed low magnitudes of sediment delivery, while 1 (20%) showed evidence of moderate-magnitude inputs of sediment to a Class III watercourse. The tractor crossing with the highest magnitude of sediment delivery had crossing approaches that appeared to be untreated with mulch or slash (Figure 22). Despite the fact the watercourse was a Class III, the active width of the watercourse was 10-12 wide and 2-3 feet deep. The relatively large dimensions of the channel and coarse-grained substrate meant that more residual fill material was left behind in the relatively large crossing area after crossing removal.

Figure 22. Pulled tractor crossing on a large Class III watercourse. The crossing delivered a moderate magnitude of sediment.

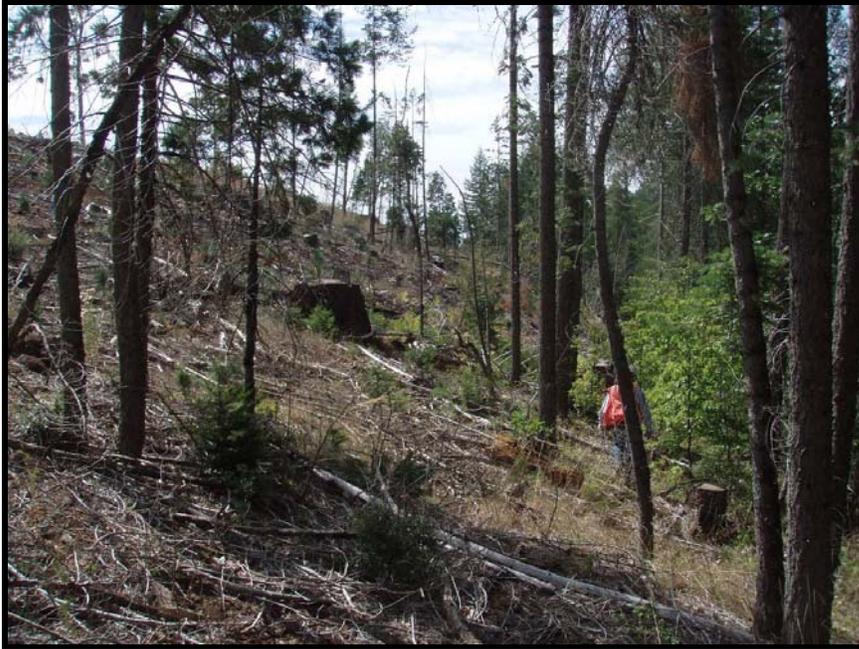
Where sediment from an erosion feature was observed to leave the clearcut unit, the sediment was observed to rapidly deposit within the adjacent riparian buffer. Riparian buffers generally have higher infiltration rates and denser surface cover than the harvested clearcut units. Hence, runoff quickly infiltrates and sediment is rapidly deposited on the forest floor in the buffer zone. In general, the Task Force found the Forest-Practice-Rules-mandated buffer zones for Class I, II, III watercourses to be sufficient to filter observable sediment from the clearcut units. The minimum buffer zones implemented in the assessment area were 25 feet wide for Class III watercourses on relatively gentle slopes (<30% slope), and the Task Force found no evidence of sediment from the clearcut units traveling

Figure 23. The interface between a clearcut harvest unit and a riparian buffer zone for a Class I watercourse in the assessment area. Surface cover and hydraulic roughness provided by dense surface cover limits runoff generation and erosion within the unit. If sediment leaves the unit, runoff is dispersed and sediment is quickly deposited within the riparian buffer.

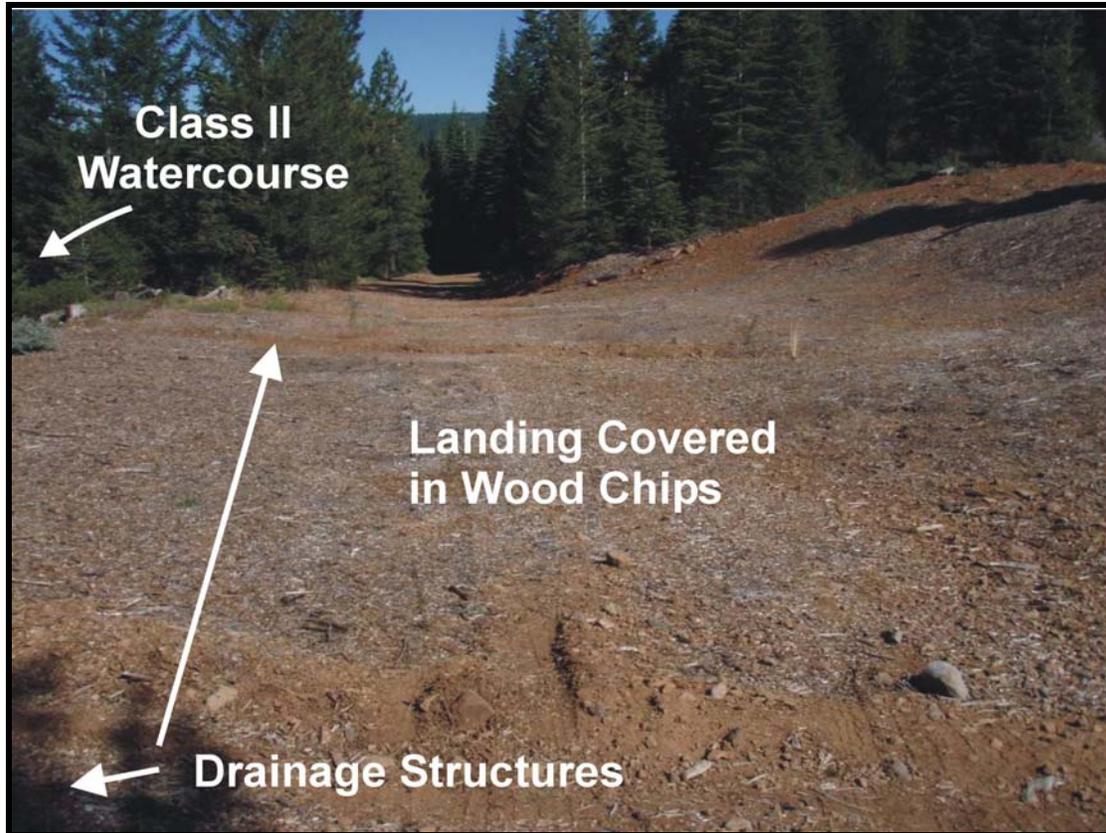
Five of the six watercourse-adjacent landings did not deliver sediment, despite some of them being as close as 20 feet to a watercourse. The only instance of observable sediment delivery from a landing was attributed to an older landing that had not been utilized for recent timber-harvest activities. The lack of sediment delivery from more recent landings was attributed to the high surface cover provided by application of wood-chip mulch. These landings were utilized for biomassing activities, so an abundant supply of wood chips was available onsite. The woodchips provided protection against rainsplash erosion and associated soil sealing. No runoff was visible across the surface of the chipped landings (Figure 24).

Figure 24. A landing located within 20 feet of a Class II watercourse. No observable sediment was delivered from this site due to the high level of surface cover provided by wood chips.

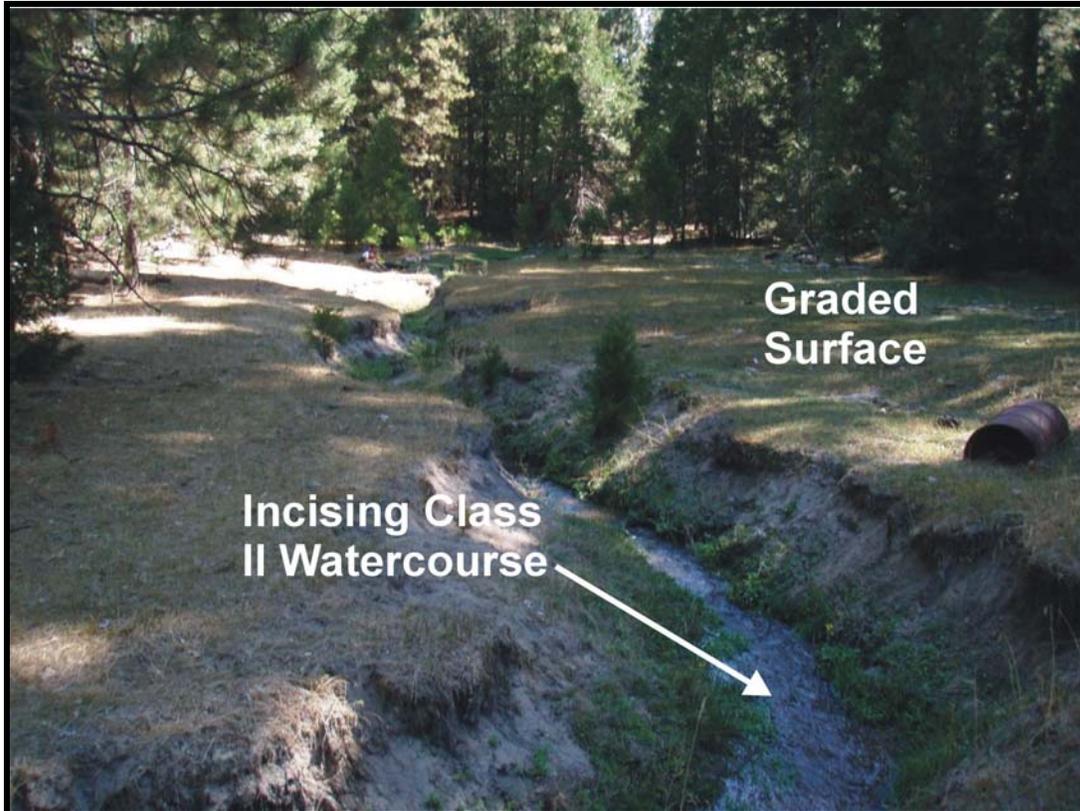
Figure 25. Extensive channel incision at a legacy sediment site in the Bailey Creek planning watershed. This location had the highest magnitude of sediment delivery of all the surveyed sites.
